## EXTERIOR - FOUNDATION-STRUCTURE

### STRUCTURE

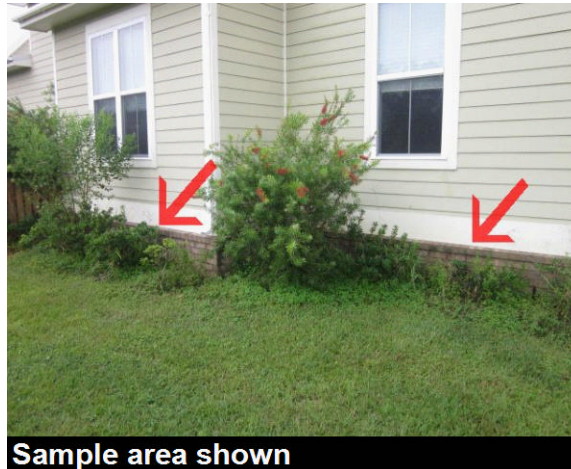
No visible flashing where the exterior side walls meet the brick. This can allow moisture inside unless properly flashed and or sealed.

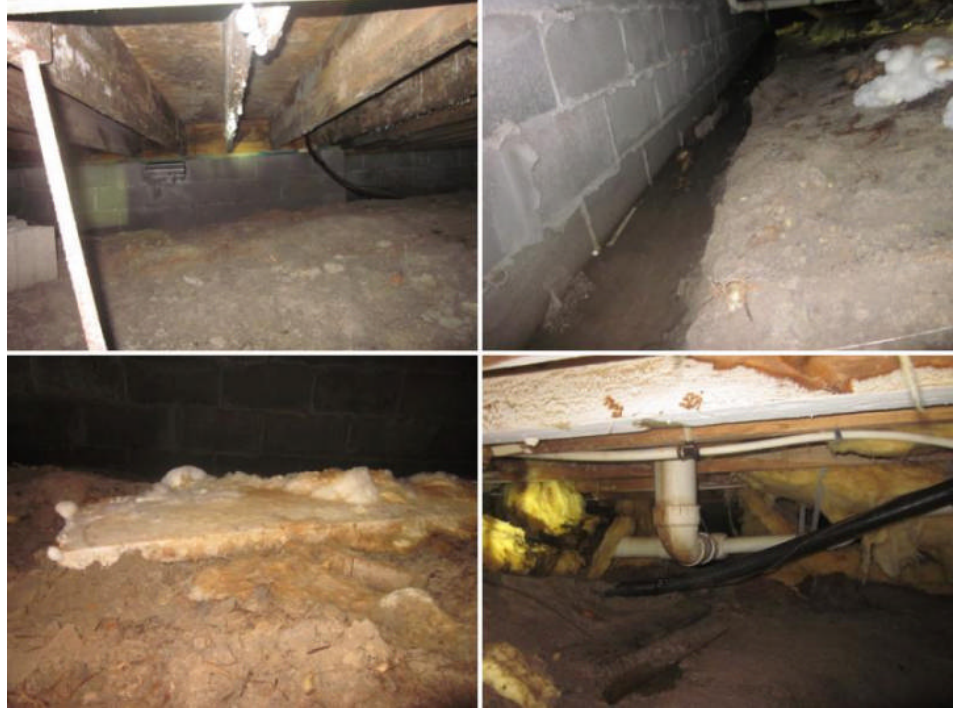
Water has been entering into the crawlspace from both the exterior and the master shower. Over time this has caused water damaged framing, insulation, flooring and extensive mold.

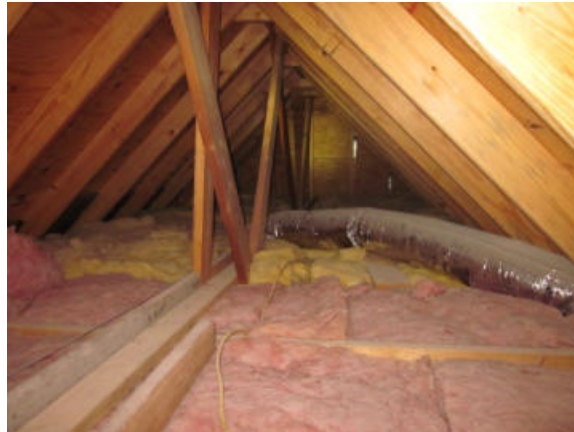
Attic was only partially observed due to construction / framing design.

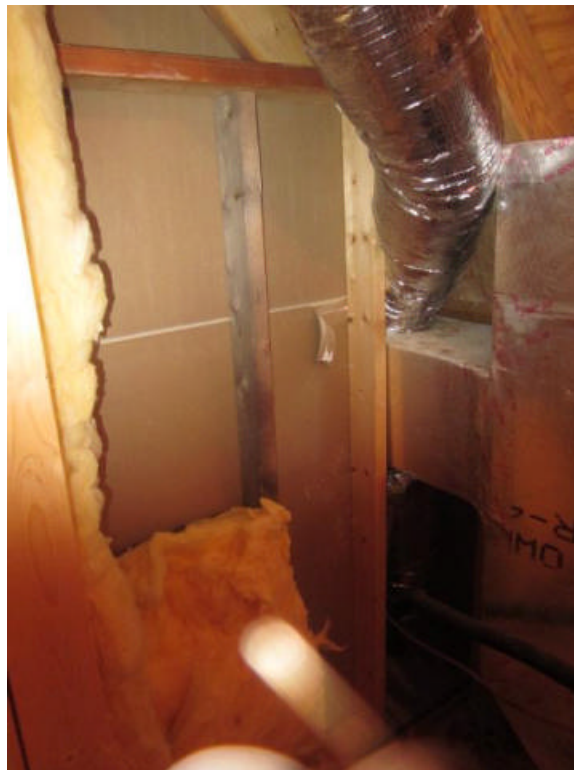
Fiberglass batts (Blanket)

Insulation is out of place in the 2nd floor attic at the north closet.

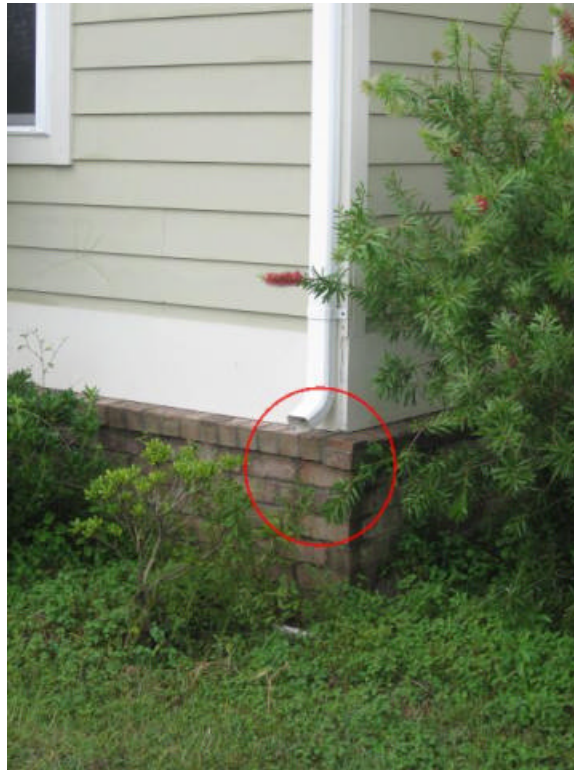
Plastic, overall general condition is OK.

Route downspouts away from the building. Ideally the water will be directed 3+ feet away from the foundation.

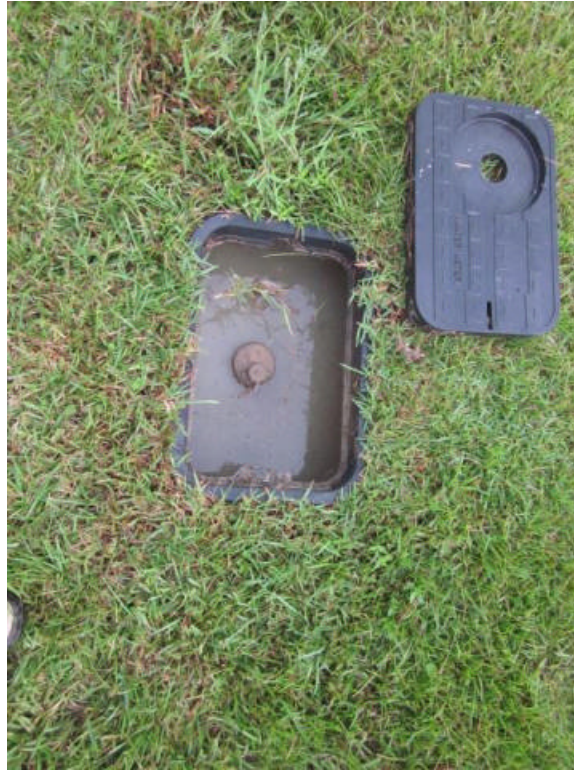
Water meter is located at the front side of the house  
There is water inside the meter box. Since the meter is not moving, it is likely due to a high water table and recent rains. Recheck after it is dry for a few days.

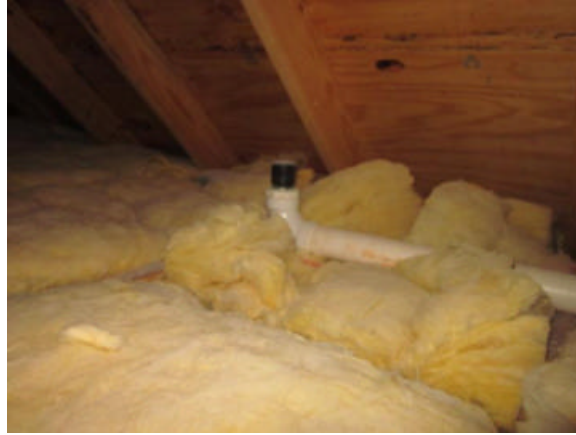
The wrong style valve has been installed in the attic. The problem arises when builders or plumbers install what is called a Mechanical Vent in place of an Air Admittance Valve or AAV. Mechanical vents are not allowed in residential homes, only the AAV should be used.

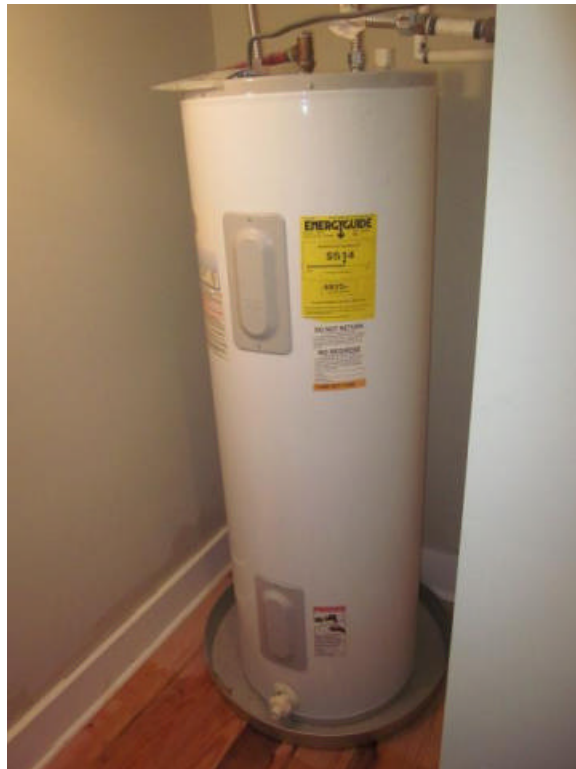
Operational at this time, The temperature setting(s) is between 120F and 125F degrees which is considered safe and economical.

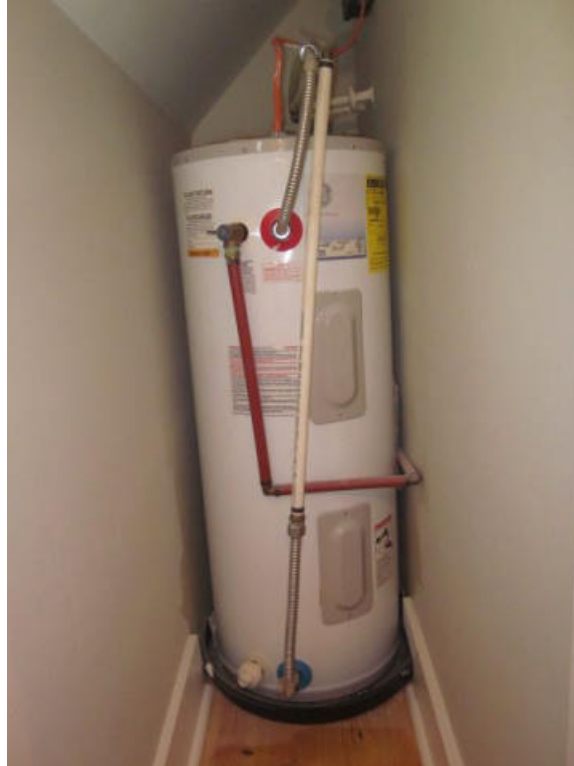
Operational at this time, The temperature setting(s) is between 120F and 125F degrees which is considered safe and economical.

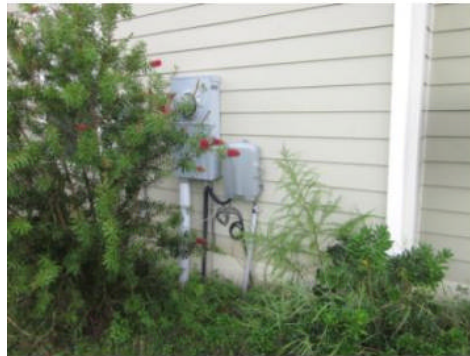
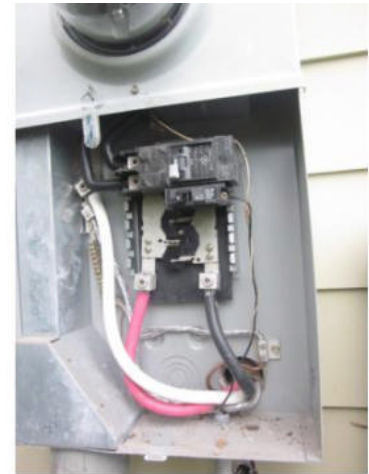
Circuit and wire sizing correct so far as visible, there is visible anti oxidant paste on the aluminum wires, I could see no signs or overheating or double taps and the panel is properly labeled

Improper clearance to access the panel. There should be 3 feet of working room clearance in front and 30 inches at the sides of the panel.

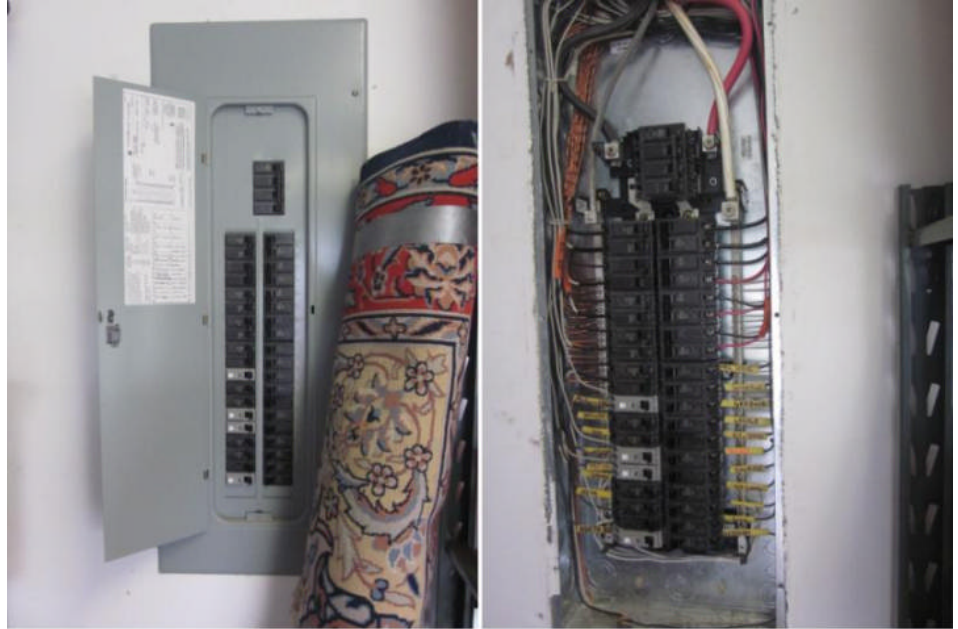
Circuit and wire sizing correct so far as visible

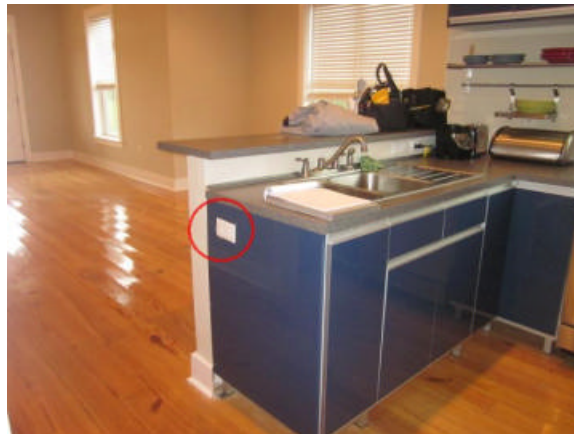
There is an outlet at the side of the kitchen cabinet. It is placed at a height that if an appliance was plugged in, a child could easily grab the power cord and pull the appliance off the counter top.

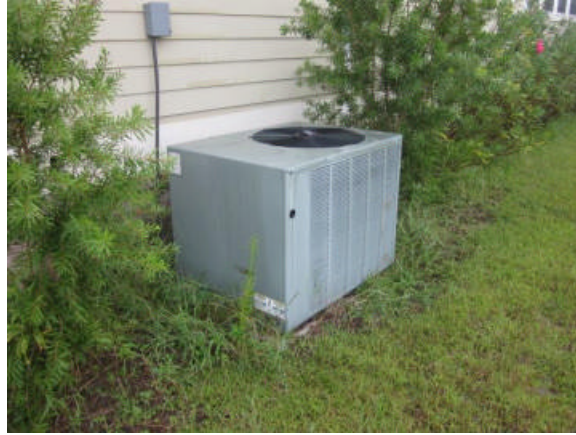
Good overall condition.

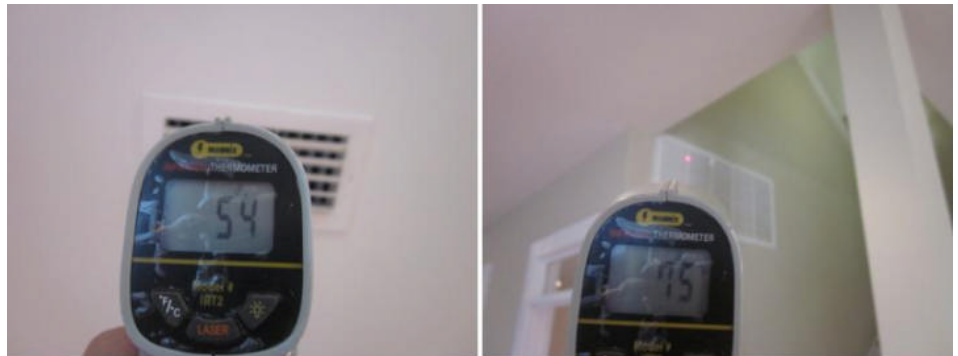
The temperature difference between the intake and register is between 12-20 degrees. This is normal for this air conditioning unit.

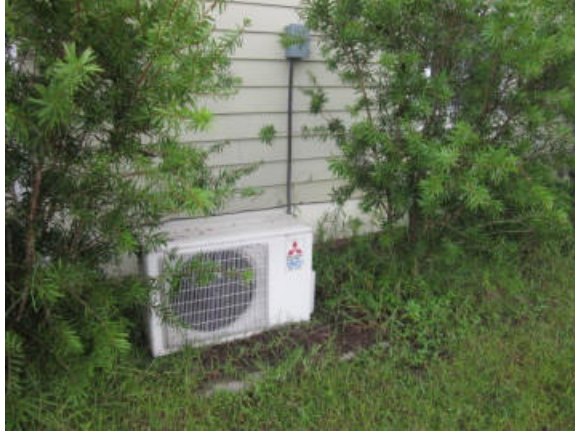
Good overall condition.

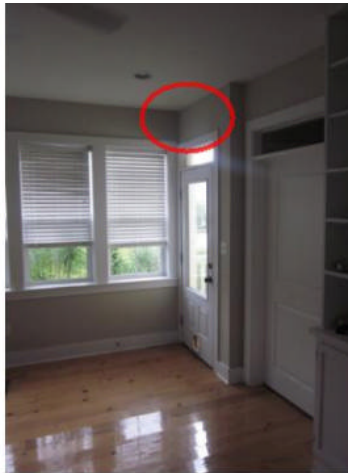
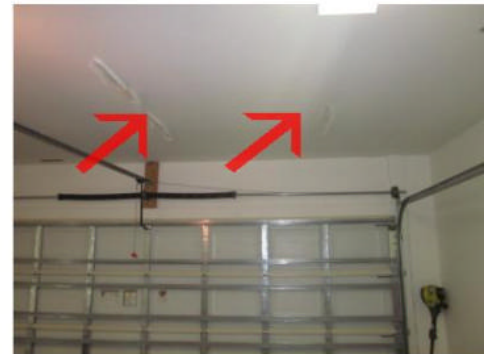
Water stains in the living room by the front door and in the garage by the overhead door. I could not confirm a cause or correction. Inquire with the seller.

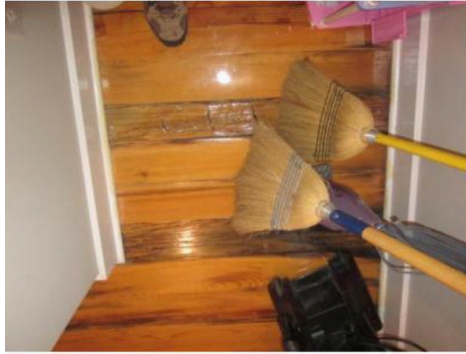
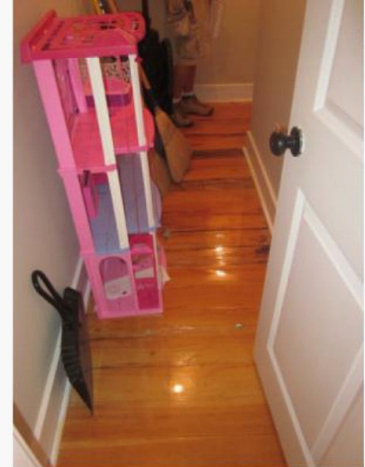
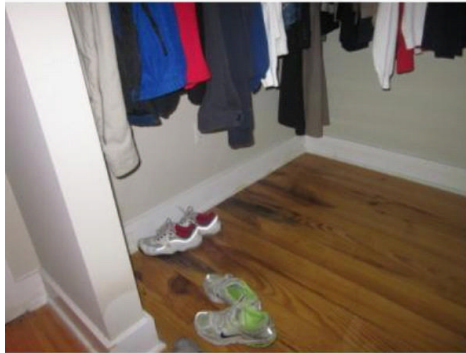
**Sample areas shown**

Wood flooring at the first floor is warped from moisture below.

Wood floor has some visible wood rot in the vicinity of the master shower and beyond.

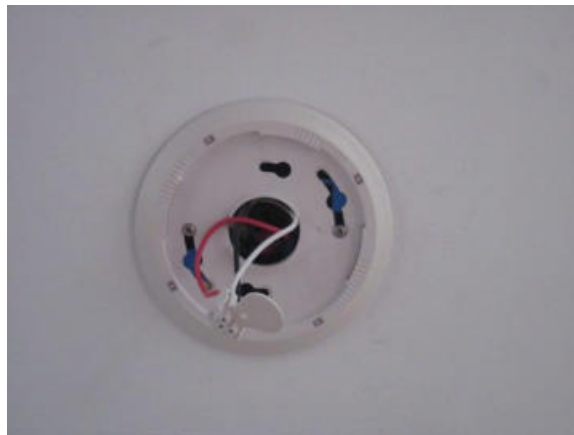
Smoke alarm(s) responded to test button operation. (It is your responsibility to make sure they are updated as required by the manufacturer and local building code.)

Smoke detector is missing in the living room.

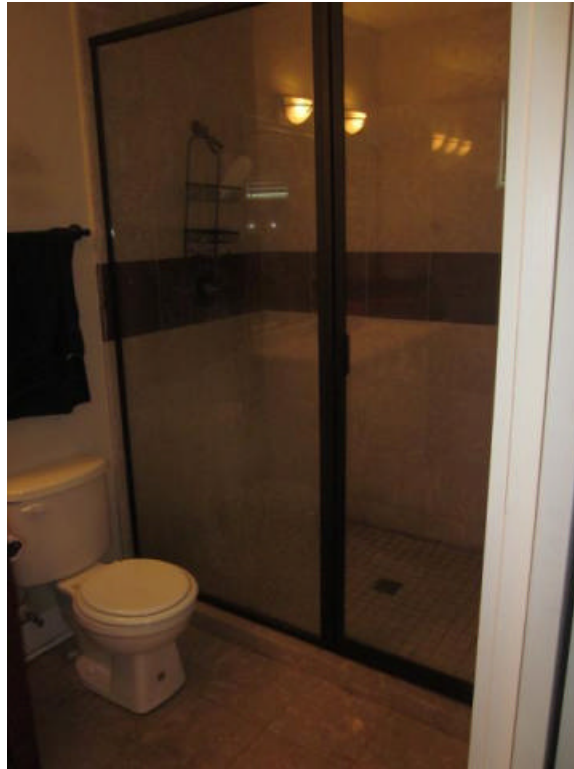
Master shower walls, floor and pan are leaking causing extensive damage to the surrounding areas and below into the crawlspace.

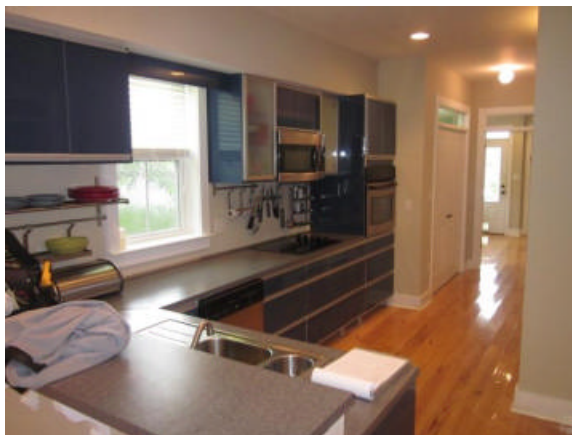
The counters, cabinets, doors, and drawers are satisfactory in both appearance and function.

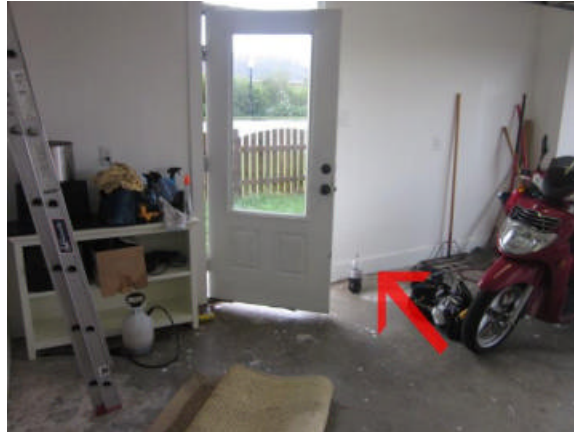
Water entering into the side garage door and vicinity.

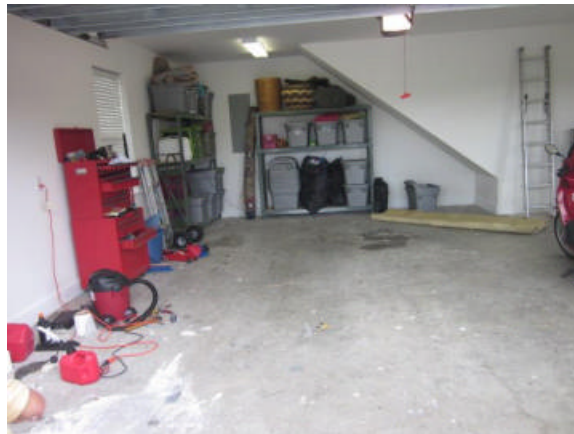
Typical cracks noted.

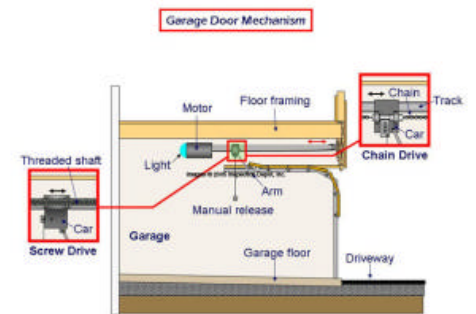
Door sensors are installed at the wrong height / place. It is recommended that the top of the photoelectric eye lens is no higher than six inches above the garage floor.

The door operates louder than normal. Adjustments and or repairs may be needed to quiet it down.

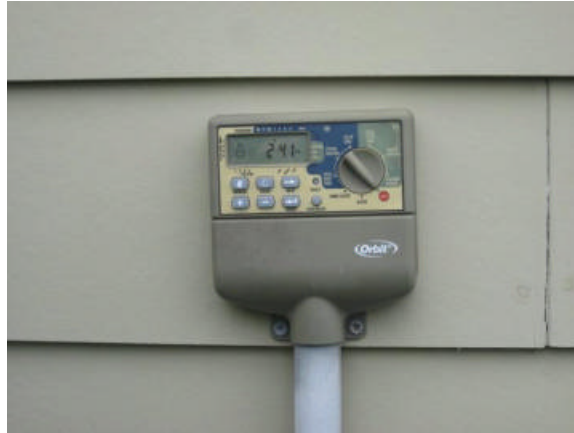
The timer is located on the exterior wall and is functioning properly at this time.

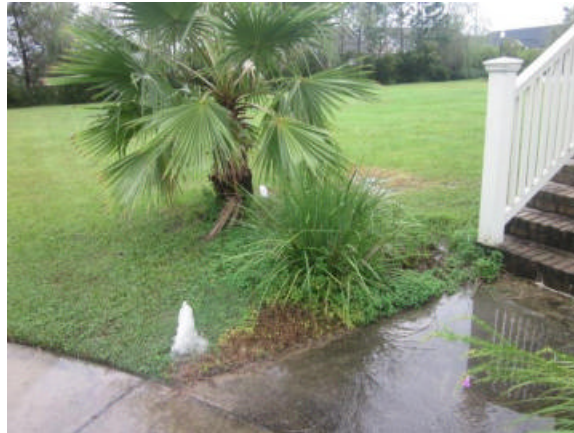
Heads are broken and I could not get enough water flow to test the sprinkler system.

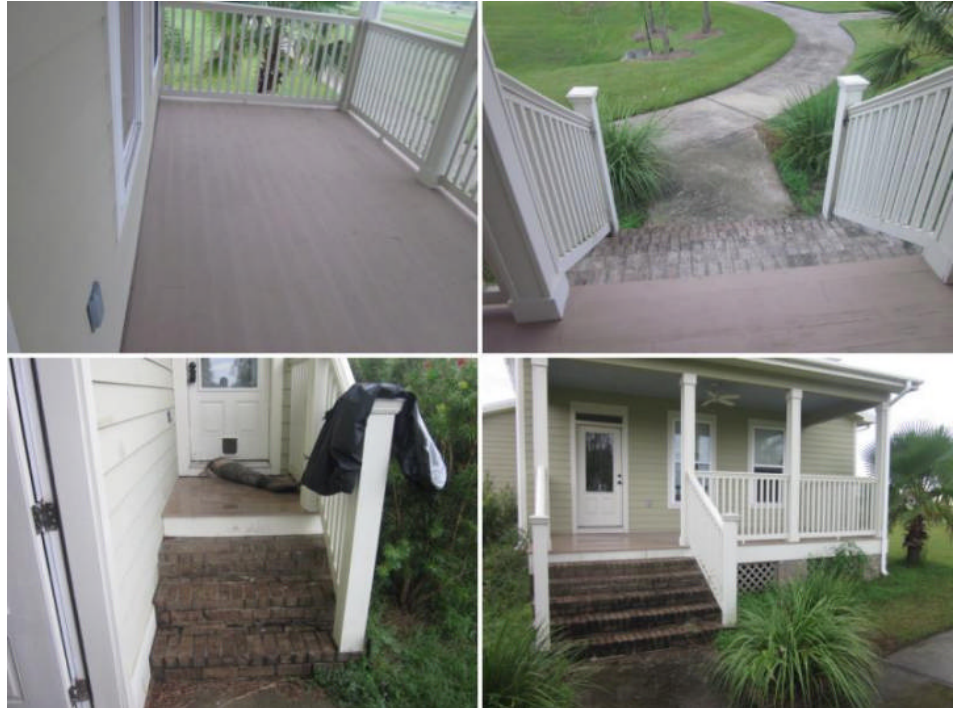
Not much of a slope of the decks away from the home.

Due to the amount of wood rot at both the front and rear decks and railings, confirm it is wood designed to be exposed to weather.

Repair wood rot at both front and rear decks and railings

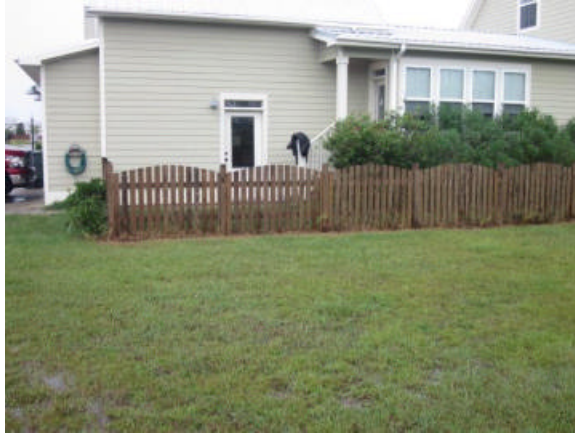
Good overall condition.

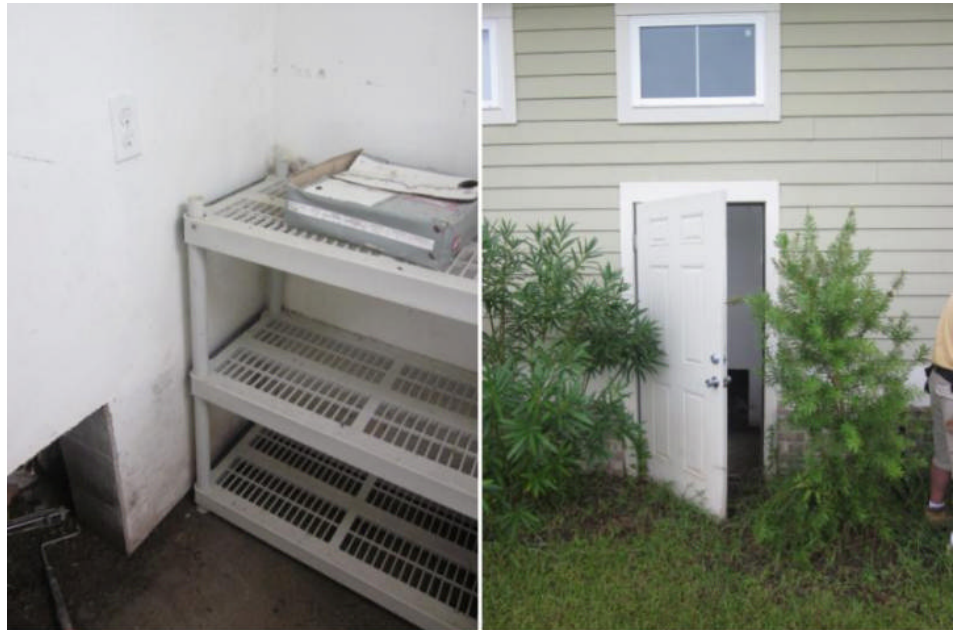
Storage shed has wood rot inside and out, at the door and there is a mold growth inside.
