April 27, 2004

REPORT SUMMARY

Jim Ellis
President
Ellis Inspection Services, Inc.

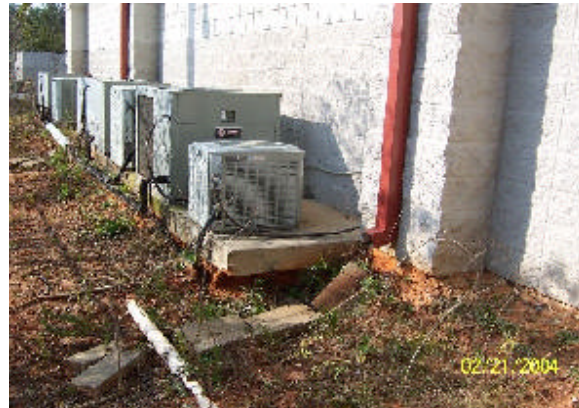
1. Soil erosion needs to be stopped and minor filling in under the slab on the west side of the building. Some a/c slabs have voids under them.

Soil erosion needs to be stopped and minor filling in under the slab on the west side of the building. Some a/c slabs have voids under them.

Grading: Improvement needed at the west side. Depressions or low areas are noted - They present a tripping hazards, particularly when they occur next to paved or regularly used areas. Fill depressions to reduce liability.

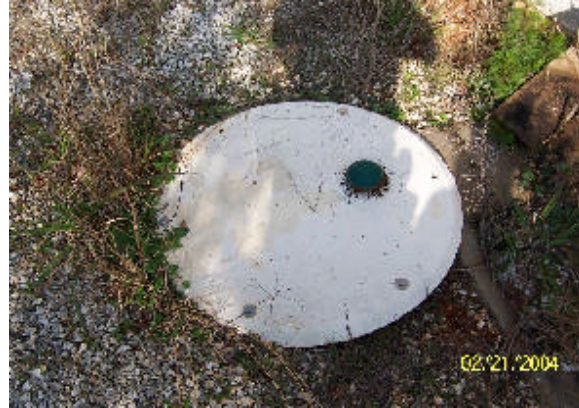
Septic pump is missing bolts from the cover and the vent is rusting through and will need replacement soon.

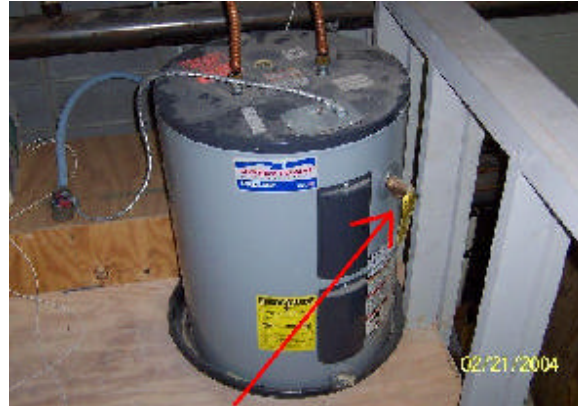
2. Electric 38 gallon water tank in the back upper loft needs a temperature pressure relief tube installed.
Heater under kitchen sink is inoperable.

Electric 38 gallon water tank in the back upper loft needs a temperature pressure relief tube installed.
Heater under kitchen sink is inoperable.

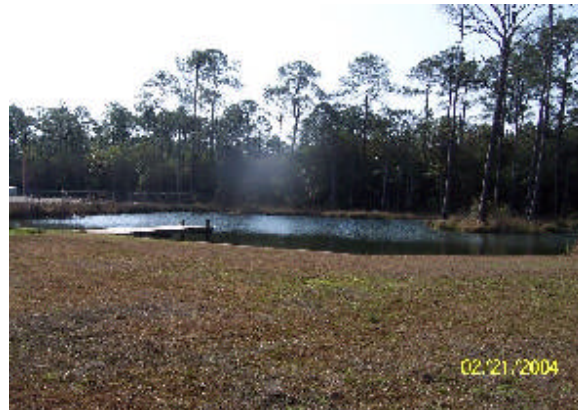
Pond aerator does not function.

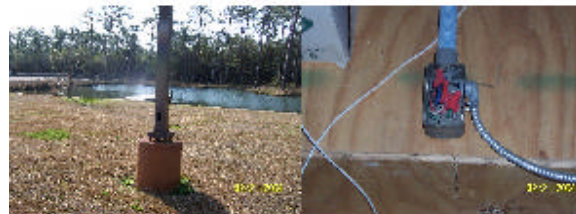
3. Electrical wiring junctions not contained within covered electrical junction boxes are a FIRE HAZARD and are noted in the following locations: Front & rear attic chase / back room by water heater / north west ceiling / rear exterior lamp poles / power supply by water heater / missing fixture by lower dressing room with exposed wires.

Sample areas of missing covers

Electrical wiring junctions not contained within covered electrical junction boxes are a FIRE HAZARD and are noted in the following locations: Front & rear attic chase / back room by water heater /

north west ceiling / rear exterior lamp poles / power supply by water heater / missing fixture by lower dressing room with exposed wires.

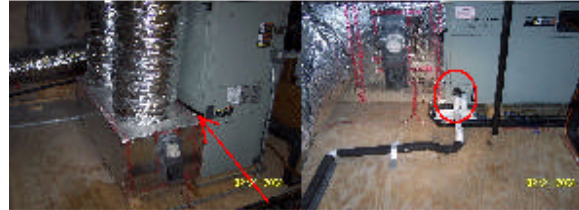
Heat temperature 90
Heat strips / failed to operate. Review by HVAC contractor
The temperature difference between the intake and register is between 14-20 degrees. This is normal for this air conditioning unit.
Seal broken conduit at condensing unit.

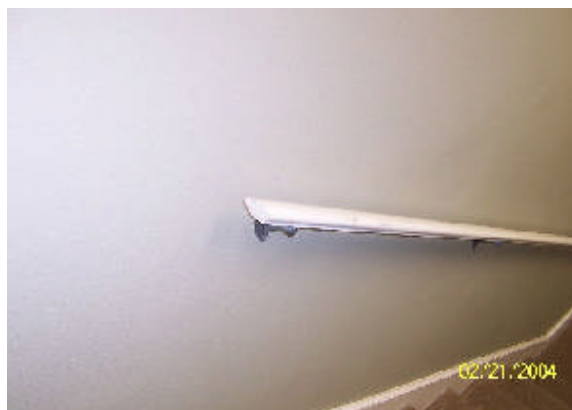
The stair handrail should be closed on the end as to not allow clothing, purses etc. to catch and become a fall hazard.
