# HOME INSPECTION REPORT

*Ellis Inspection Services, Inc.*

At your request, a visual inspection of the above referenced property was conducted on January 4, 2007. A home inspection will not reveal every problem that exists or ever could exist, but only those material defects observed on the day of the inspection.

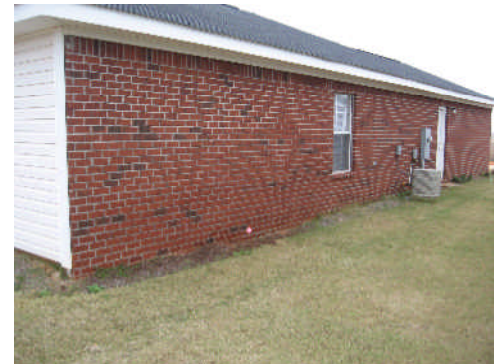
A) I could not find the flashing that is normally required for brick veneer weep holes. There have been some weeps added above and below the windows and near the slab

B) The left side of the brick wall moves with only moderate pressure applied.

C) With the use of a garden hose on medium force, I was able to detect water leaking into the bedroom wall.

D) Brick / mortar work is not very neat and I do not understand the cracking around the side window framing

E) The lintels are not finished, most of these should be protected from rusting

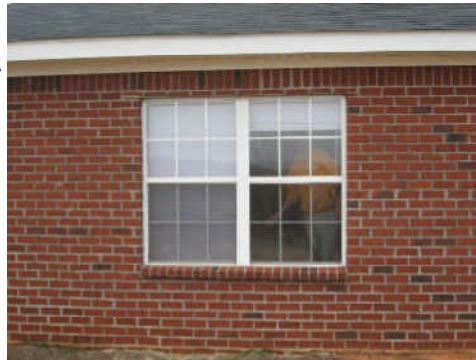
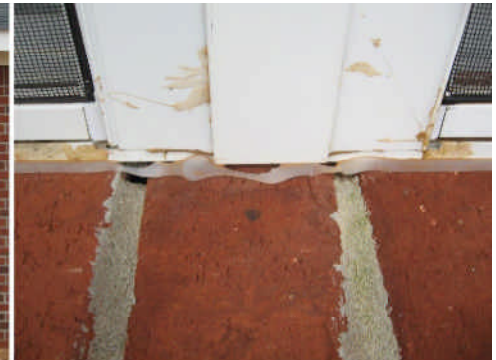
Some window ledges are basically flat. To prevent a problem at a later date, it would be advised to keep a good caulk joint at the windows and apply a mason sealant as recommended by the manufacturer.

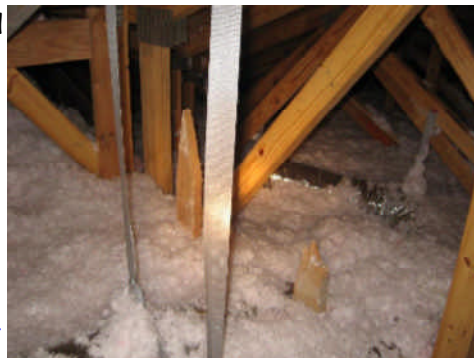
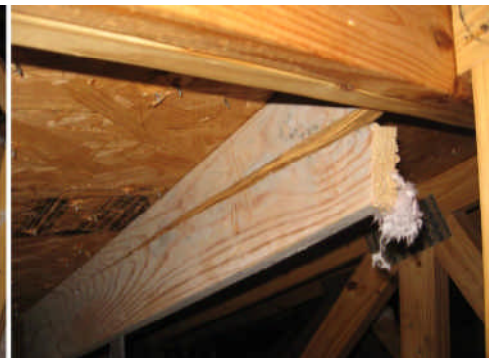
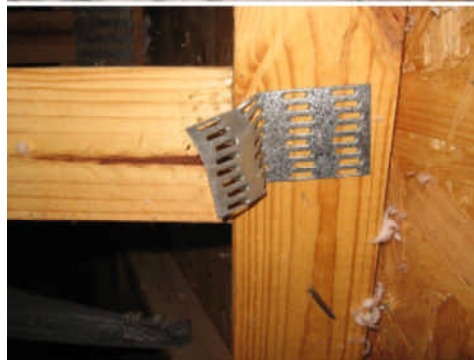
There is broken roof frame in the attic (10 feet north west of the attic access) and 2 pieces of unknown origin in the same area.

Near the 4 inch vent pipe in the attic is a truss with a no longer attached gusset plate

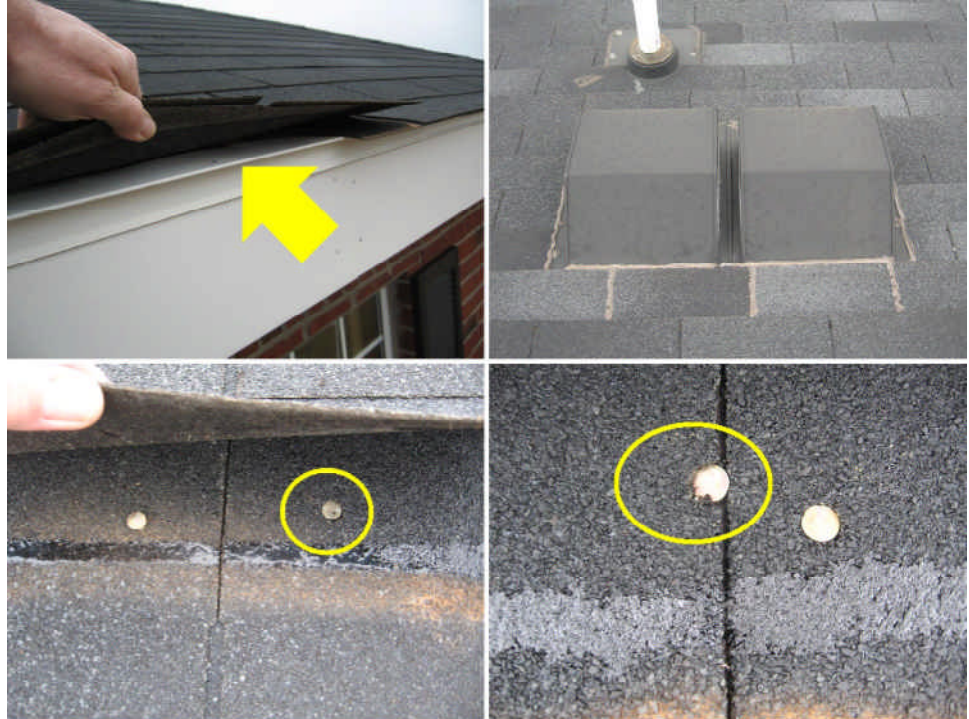
Nails/Fasteners are protruding from the roof surface. It would be advised to set the nails and seal the shingles back down to prevent water intrusion.

Nail heads are showing and should be sealed to prevent moisture entry, Roofing mastic has been used to stop water leaks. This is common on this style roof, it should however, be monitored closely and reapplied as needed.

I lifted a sample of shingles and found some nails over driven, some under driven, some in the wrong section of shingle and only 4 (four) nails per shingles.

Most roofing manufacturers recommend

sealing the bottom shingles to the drip edge flashing, this has not been done here and is recommended.

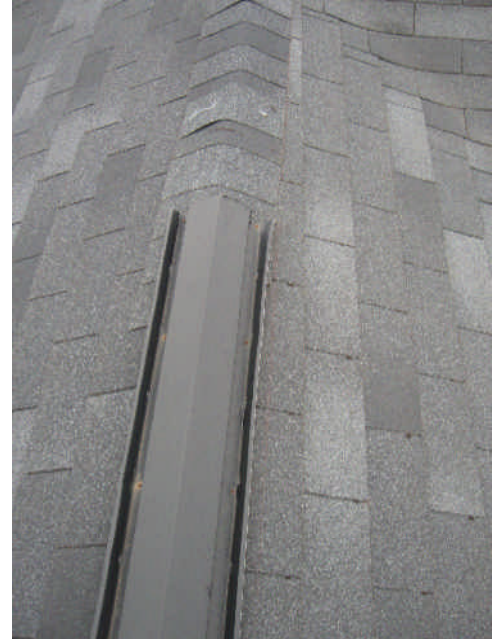
The potential for water entry is present Seal and secure ridge vents.

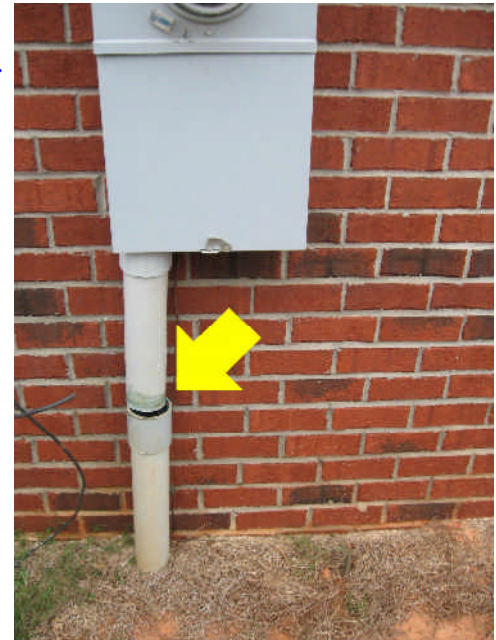
The conduit has become loose going into the main exterior panel.

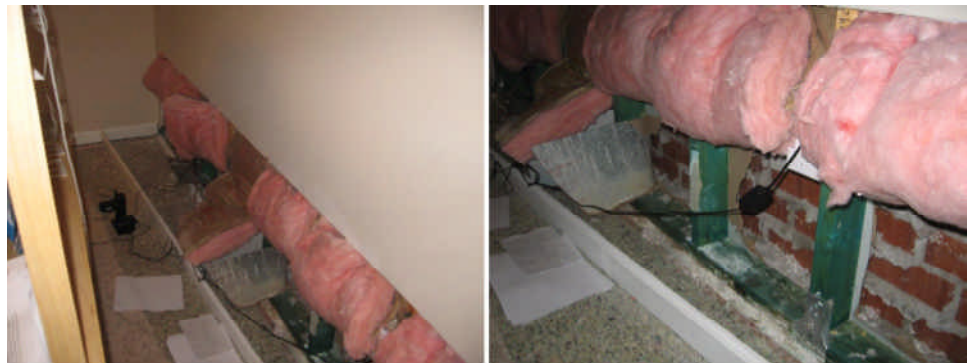
The lower section of the bedroom wall has been removed to view water leak results and entry points into the home.

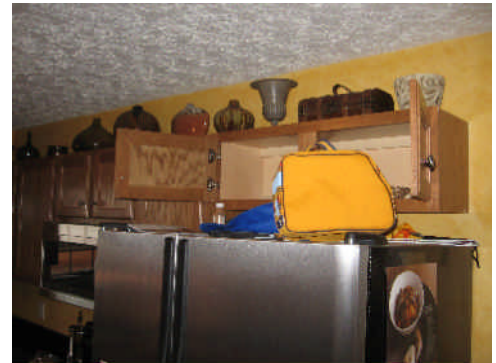
The cabinet over the refrigerator is loose and is pulling off the wall

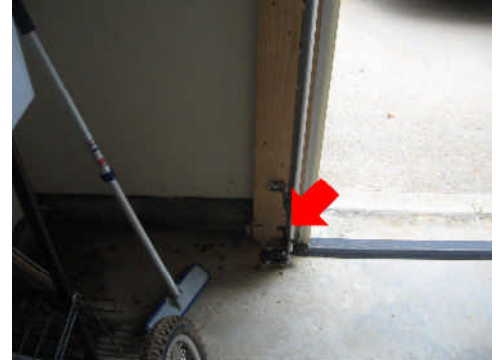
The wood framing around the garage door does not appear to be pressure treated and is resting on the cement floor.

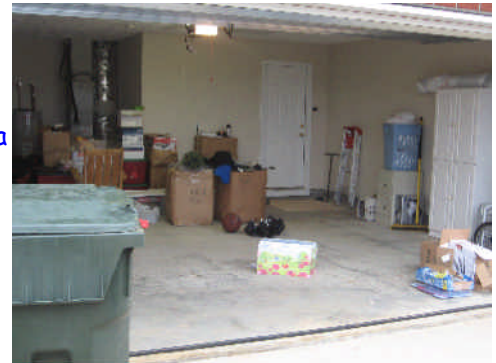
Typical cracks noted.

309.3 Floor surface.

The area of floor used for parking of automobiles or other vehicles shall be sloped to facilitate the movement of liquids to a drain or toward the main vehicle entry doorway.

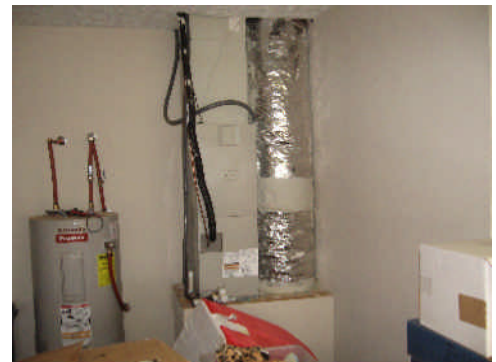
I have no way to verify the ducting in the garage is fire retardant. I suspect it is breaching the fire wall into the home and attic.

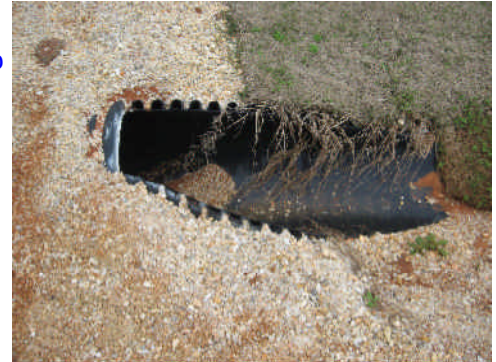
The culvert pipe at the front yard does not have any support over the top side. I do not know if how well the pipe will stand up to the pressure of automobiles
