April 27, 2004

At your request, a visual inspection of the above referenced property was conducted on February 21, 2004. This inspection report reflects the visual conditions of the property at the time of the inspection only. Hidden or concealed defects cannot be included in this report. No warranty is either expressed or implied. This report is not an insurance policy, nor a warranty service.

Jim Ellis  
President  
Ellis Inspection Services, Inc.

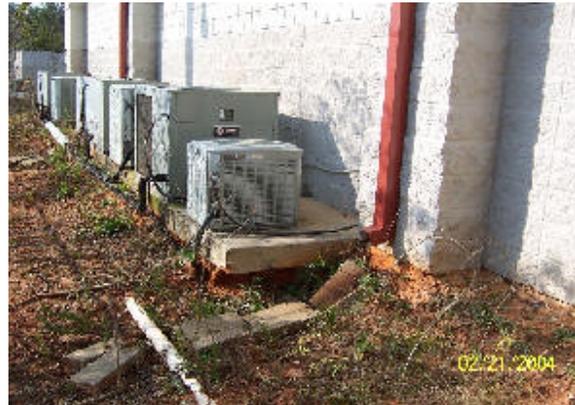
1. Soil erosion needs to be stopped and minor filling in under the slab on the west side of the building. Some a/c slabs have voids under them.

Soil erosion needs to be stopped and minor filling in under the slab on the west side of the building. Some a/c slabs have voids under them.

Grading: Improvement needed at the west side. Depressions or low areas are noted - They present a tripping hazards, particularly when they occur next to paved or regularly used areas. Fill depressions to reduce liability.

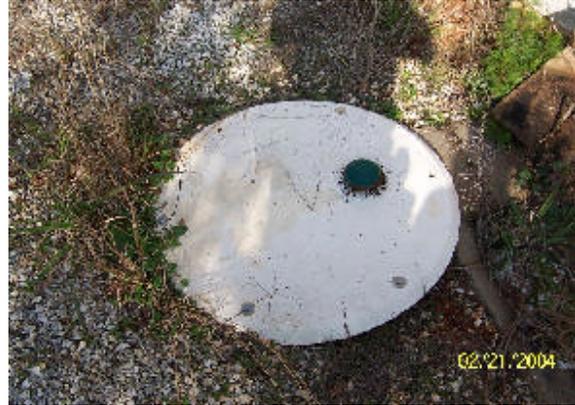
Septic pump is missing bolts from the cover and the vent is rusting through and will need replacement soon.

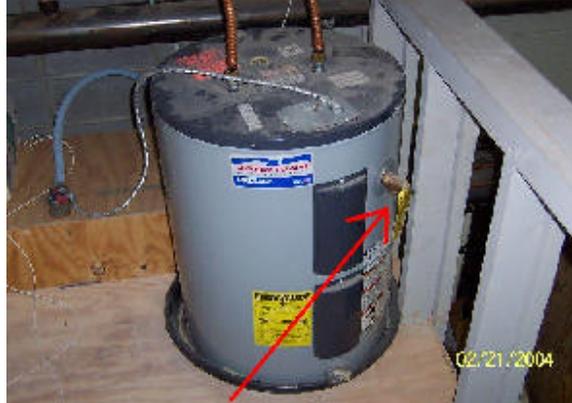
2. Electric 38 gallon water tank in the back upper loft needs a temperature pressure relief tube installed.  
Heater under kitchen sink is inoperable.

Electric 38 gallon water tank in the back upper loft needs a temperature pressure relief tube installed.  
Heater under kitchen sink is inoperable.

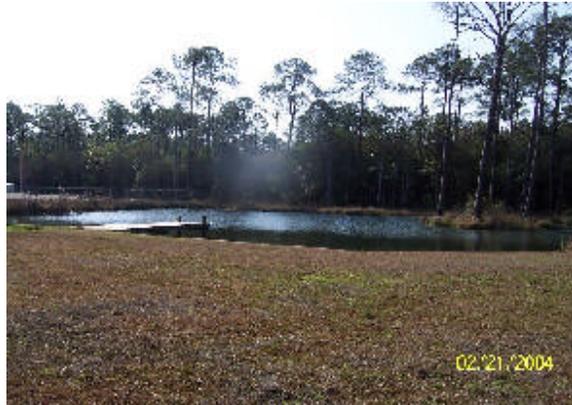
Pond aerator does not function.

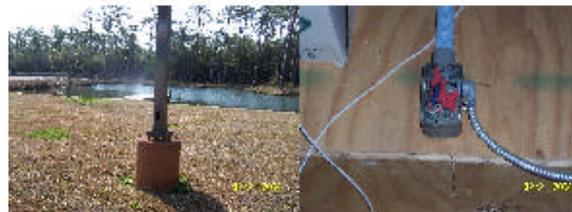
3. Electrical wiring junctions not contained within covered electrical junction boxes are a FIRE HAZARD and are noted in the following locations: Front & rear attic chase / back room by water heater / north west ceiling / rear exterior lamp poles / power supply by water heater / missing fixture by lower dressing room with exposed wires.

Sample areas of missing covers

Electrical wiring junctions not contained within covered electrical junction boxes are a FIRE HAZARD and are noted in the following locations: Front & rear attic chase / back room by water heater /

north west ceiling / rear exterior lamp poles / power supply by water heater / missing fixture by lower dressing room with exposed wires.

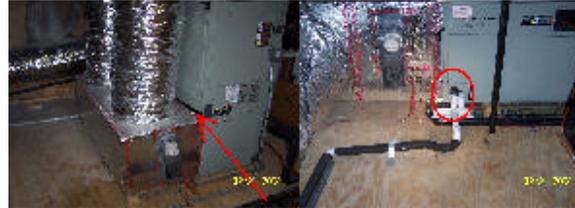
No heat pump electric heat strips responded to normal controls.  
All HVAC units need the condensate lines cleaned.  
Most units need some minor retaping of the duct work.

Heat temperature 90  
Heat strips / failed to operate. Review by HVAC contractor  
The temperature difference between the intake and register is between 14-20 degrees. This is normal for this air conditioning unit.  
Seal broken conduit at condensing unit.

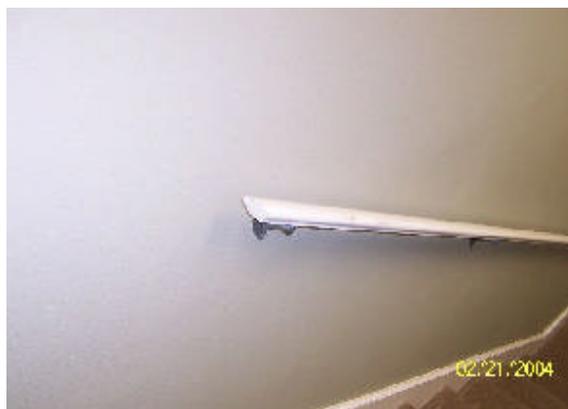
The stair handrail should be closed on the end as to not allow clothing, purses etc. to catch and become a fall hazard.
