## EXTERIOR - FOUNDATION-STRUCTURE

### STRUCTURE

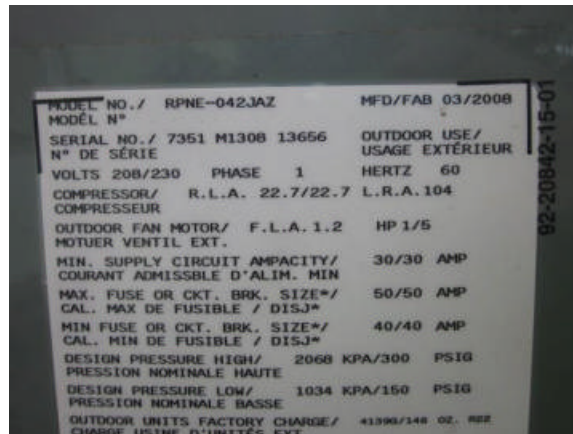
**TYPE:** Central.  
**POWER SOURCE:** Electrical disconnect present.  
**MAKE/MODEL/SERIAL**

**COMPRESSOR/CONDENSER BUILD DATE** Unit was built in 2008 This unit typically lasts 6-10 years in this coastal environment with proper maintenance.  
**CAPACITY OF UNIT:** 3 1/2 ton A/C SIZING: The general rule of thumb (many variances are not determined) for proper sizing of central air conditioner systems is that each ton of air conditioning will serve between 500 to 750 square feet of living area, given proper operation. The above listed tonnage figure multiplied times each of these numbers should give you a range into which the actual square footage of the house should fall. Many allowances should be made for building types, age, windows, insulation, etc.

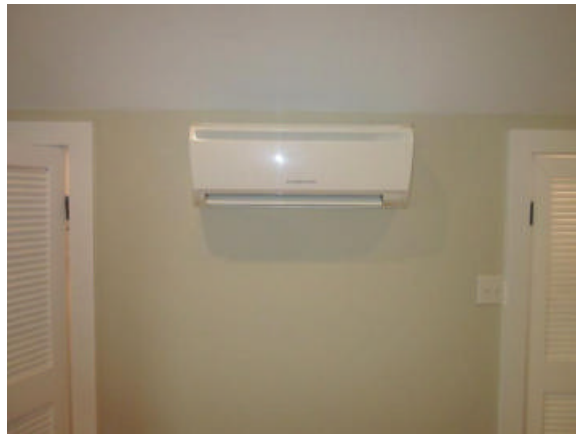
TYPE:

Wall Mounted split unit.
